Virginia Department of Transportation
INTER-AGENCY COORDINATION MEETING
Joint Permit Application

Route: 58 UPC#: 118375
 VDOT Project Number: 0058-133-459, B616, C501, USGS Quadrangle: Bowers Hill, Chuckatuck P101, R201
 City/County: Suffolk VDOT City/County Code: 133
 Contract Type: State Project Charge: 118375 Act 712
 Planned Ad Date: 12/12/2023 Designer: Walsh, Claudia A
 Project Number(Assoc)(UPC): 00460-133-25132686

This project is located in the City of Suffolk. The purpose is to construct a flyover ramp to accommodate the left turning Eastbound traffic entering the landfill. Additional right of way will be required for approximately 5 parcels. This project will have utility relocations. Currently, Route 460 is a 6 through lane facility, Lane widening will occur on both sides to accommodate the ramp. No additional through lanes are being added. The loop of the ramp is located on new location and will tie back into Bob Foeller Drive. US Route 13/58/460 has 3 general purpose lanes in each direction. The proposed design includes a right exit ramp on the eastbound lanes for the traffic entering the landfill from this direction. The flyover will be located approximately 3,000 f

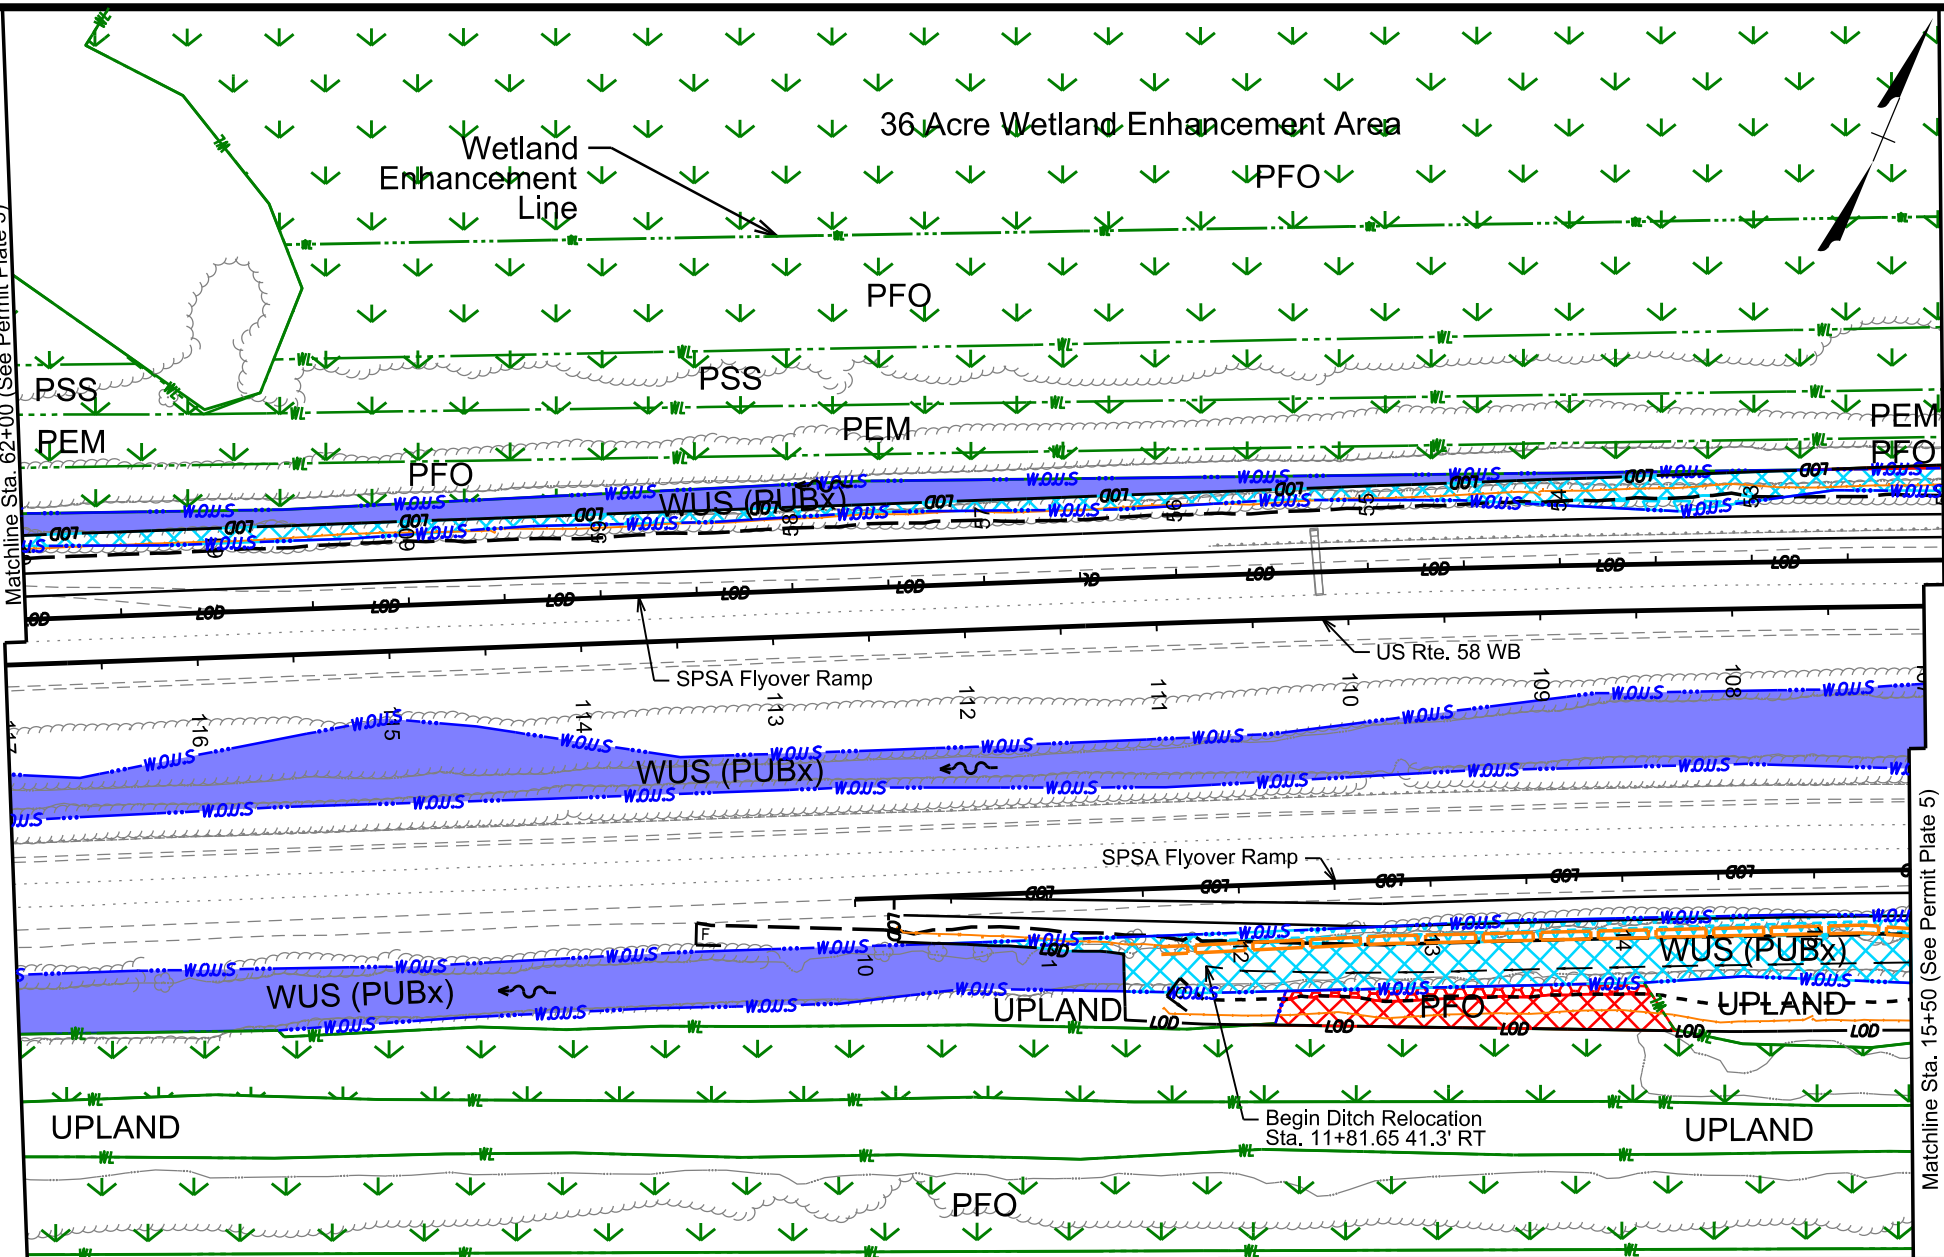
Sta. 10+00 to Sta. 15+50	Sta. 52+00 to Sta. 62+00	Date: March 2023
Application By: Virginia Department of Transportation	ROUTE 58	FILE NO. 0058-133-459 R-201, C-501
		PLATE NO. Sheet 4 of 10

PEM	PFO	PSS	PUBx	PUBx
Permanent Impact	0 SF	1,010 SF	0 SF	4,056 SF	541 LF
Temporary Impact	0 SF	3,282 SF	0 SF	17,918 SF	1,506 LF
Conversion Impact	0 SF	0 SF	0 SF	0 SF	N/A
Shading Impact	0 SF	0 SF	0 SF	0 SF	N/A

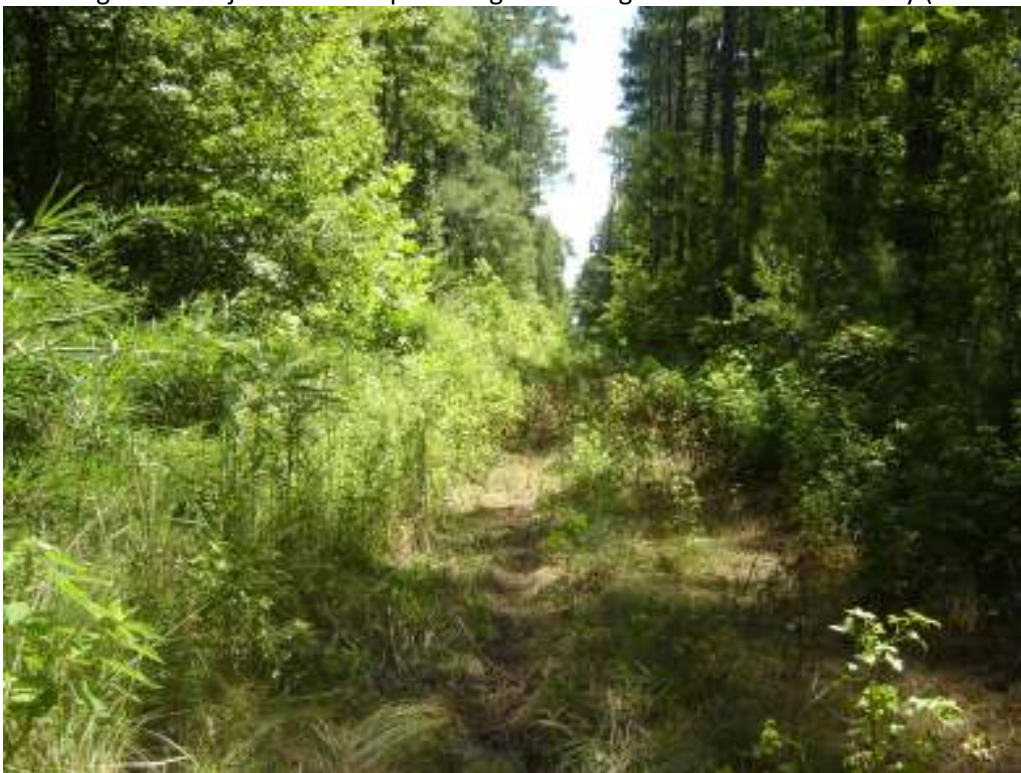
Photo 10 – Partially maintained access road containing scrub-shrub wetlands east of power line right-of-way, looking east. Project would incur minor fill (0.01-ac.) and shading (0.01-ac.) impacts within this community.

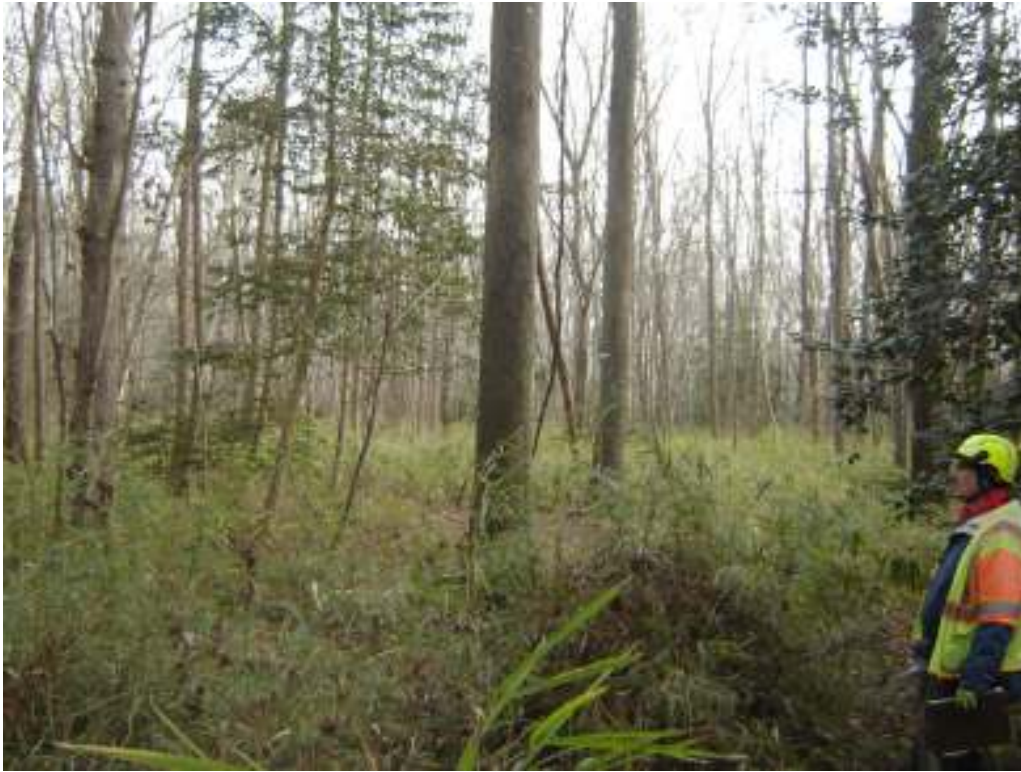
Photo 13 – Edge of mature forested wetland community looking east to immature patch of forested wetlands east of project area, looking east.

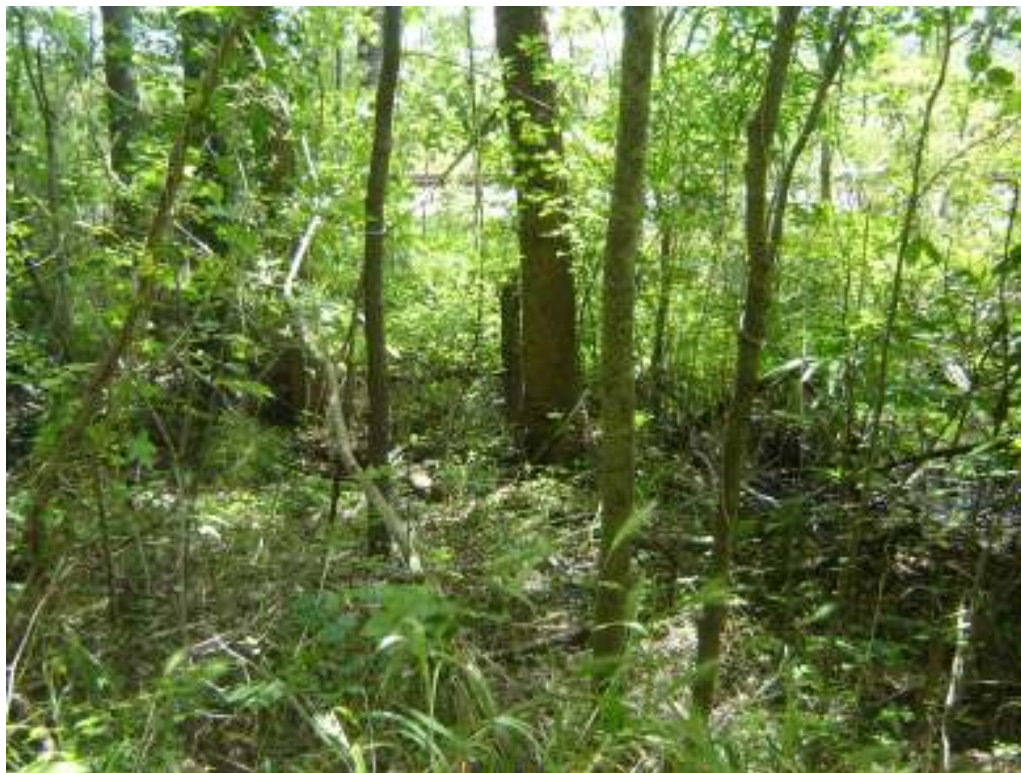
Photo 18 – View south outside of study area, showing fringe of wetlands in between historic access road and railroad. Disturbance of active railroad, historic railroad bed, roadside ditch, and US 58 EB has resulted in extensive fragmentation south of US 58 EB.

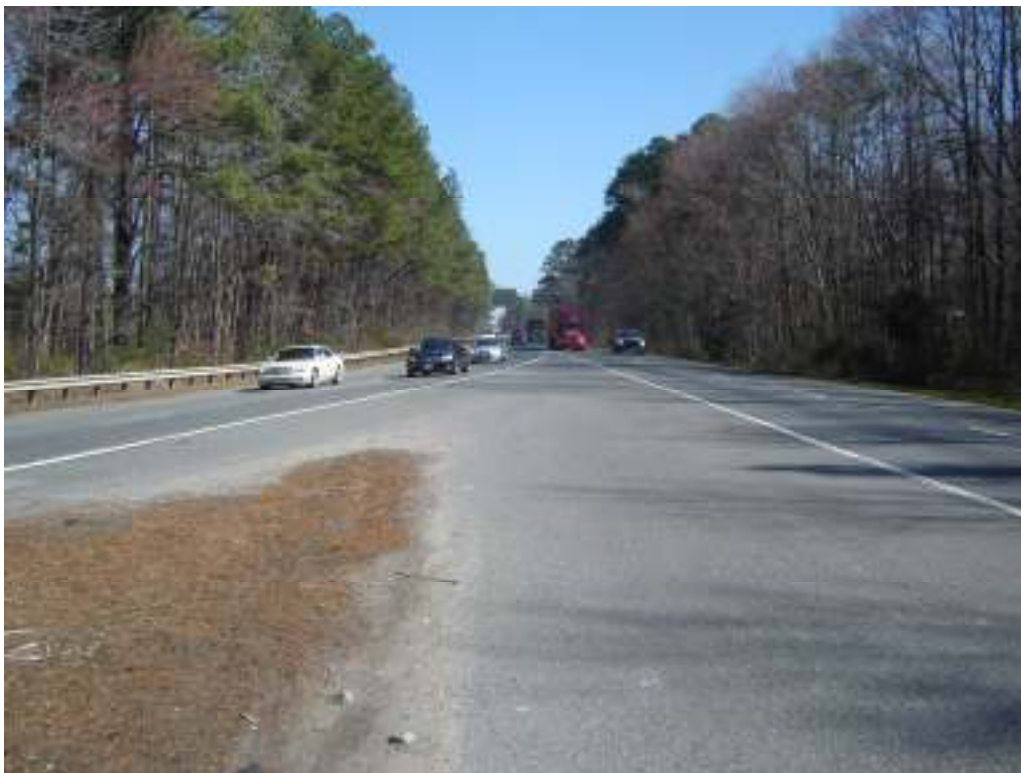
Photo 6 – U.S. 58 WB and U.S. 58 Business split; under alternative 1C (Flyover West), traffic exiting SPSA facility would be subject to unsafe merge conditions.

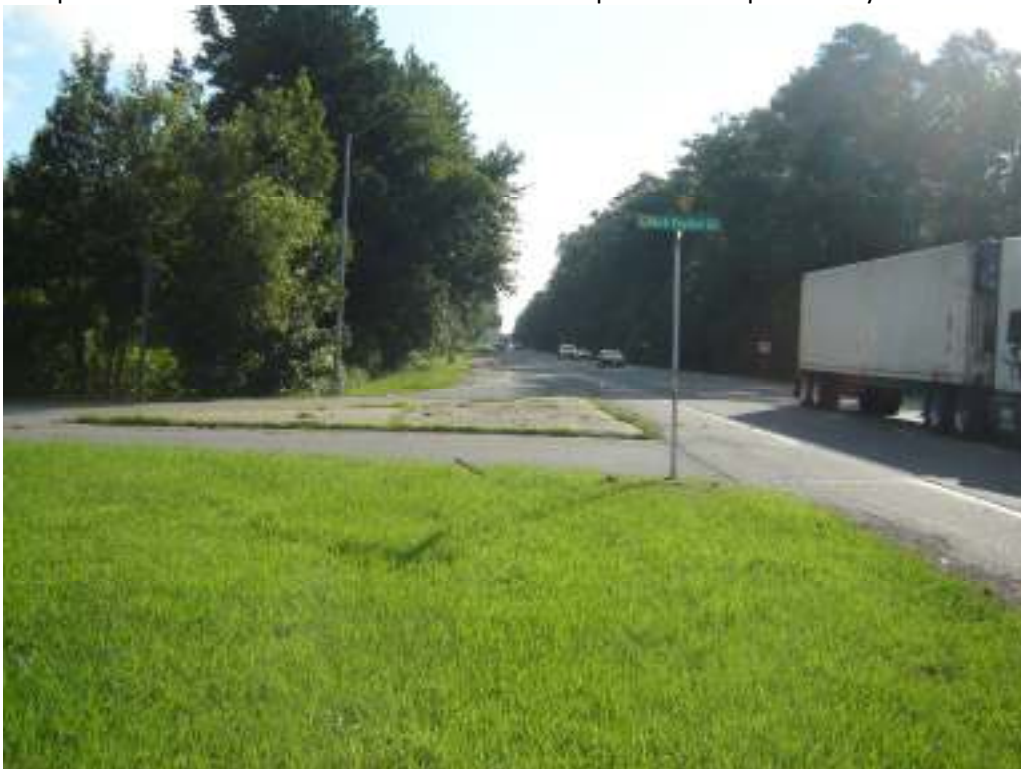
Photo 10 – Existing condition, seen from Bob Foeller Drive, looking east. No Build Alternative (Alternative 4) would not address existing and future safety and traffic issues.

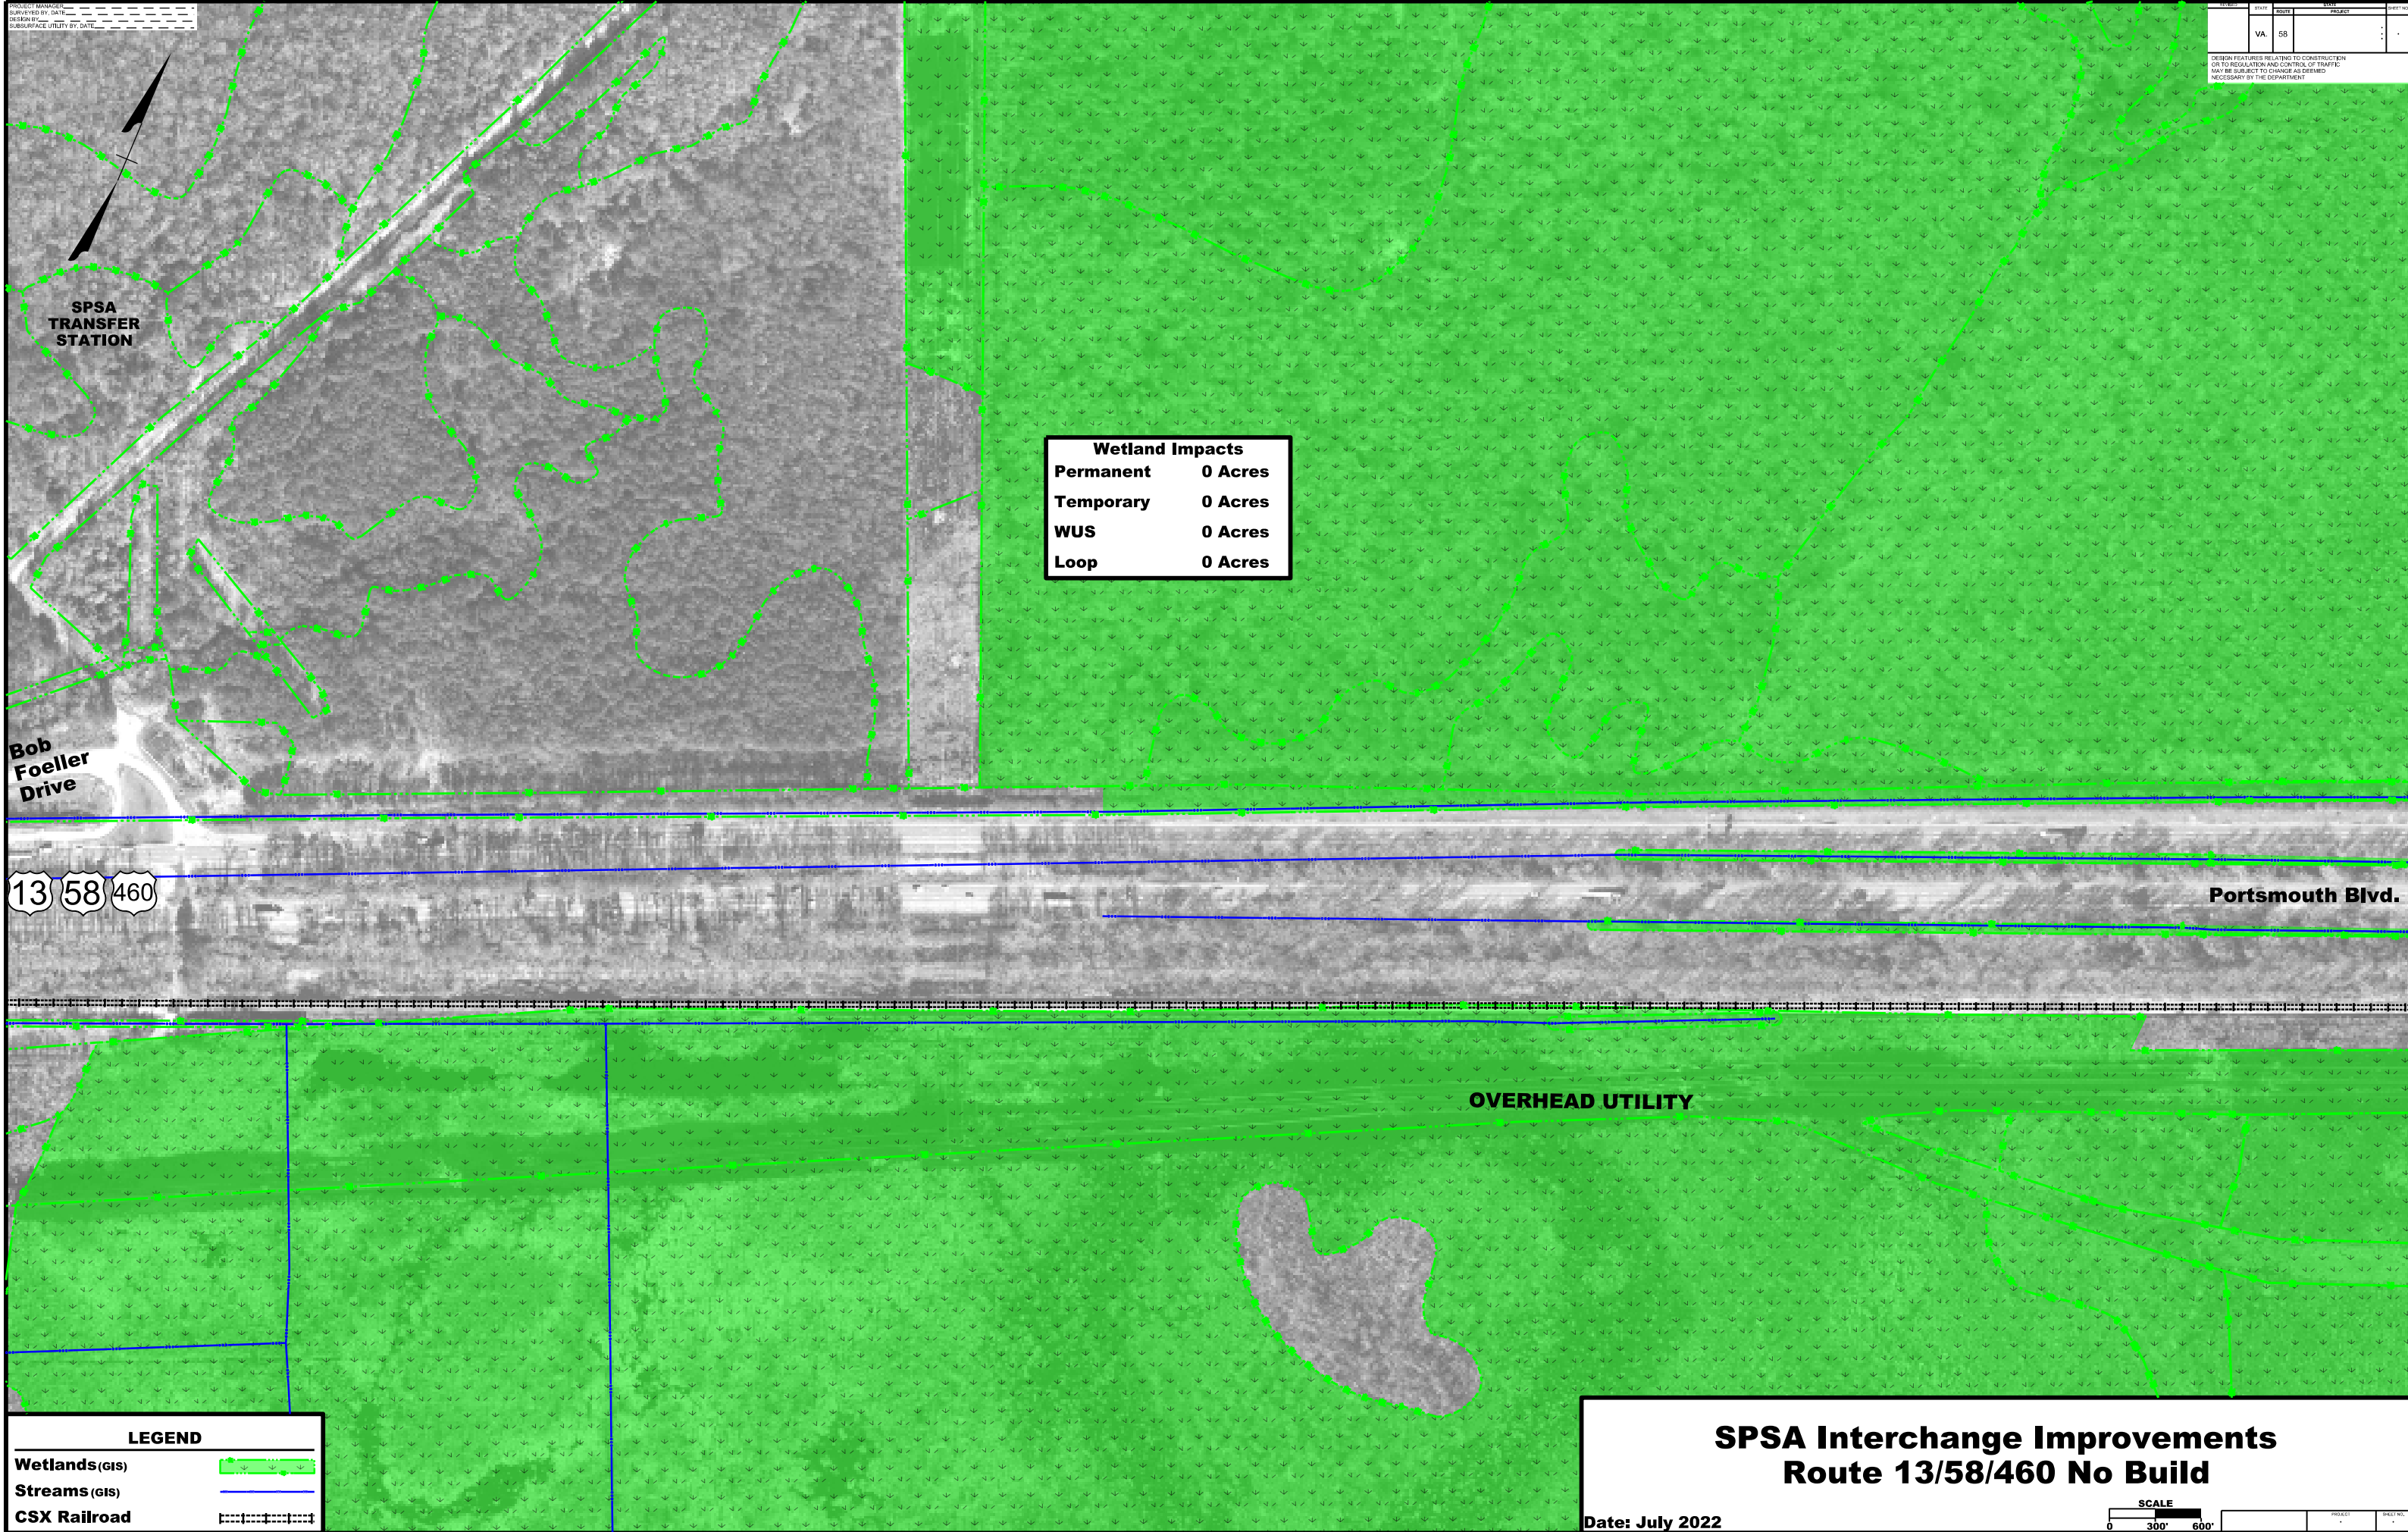
Wetland Impacts	
Permanent	0 Acres
Temporary	0 Acres
WUS	0 Acres
Loop	0 Acres
